<b>Best practice example:</b>	<b>Silt and surface water management</b>
<b>Project:</b>	<b>Ancient woodland feature translocation</b>
<b>Client:</b>	<b>Fusion/HS2</b>
<b>Location:</b>	<b>Calvert, Buckinghamshire</b>
<b>Timescales:</b>	<b>2019 – 2020 (Feasibility study)</b> <b>2020- 2021 (Translocation works)</b>
<b>Background</b>	
<ul style="list-style-type: none"> <li>The area is underlain by Oxford Clay meaning the soils do not freely drain and when wet create fine, silt particles which can pollute watercourses. Bisecting the Ancient woodland receptor site is a watercourse which connects to a main watercourse offsite and downstream of Fusion works.</li> <li>In accordance with Industry Best Practice for habitat translocation works (CIRIA C600) and to avoid ecological impacts to protected species, the works were programmed to take place during the autumn/winter season.</li> </ul>	
<b>Issues to consider</b>

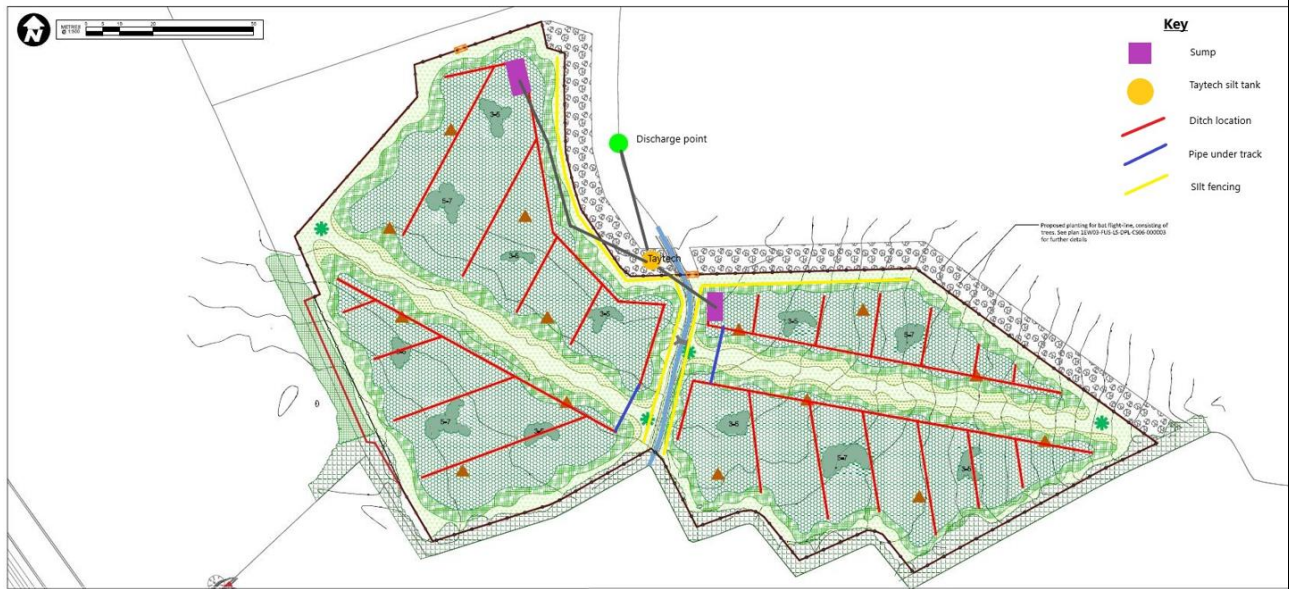
**Figure 1: Active/ passive surface water and silt management system**

- The grips connected to a central channel (at the same depth) running parallel to main haul route on each side which carried water to a collection point, consisting of deep excavated areas or 'sumps' capable of holding large amounts of water.
- From the sumps, water was pumped into a silt settlement tank and a flocculent solution was added to assist in silt settlement. Clean water was then pumped from the settlement tank and into the watercourse on site.

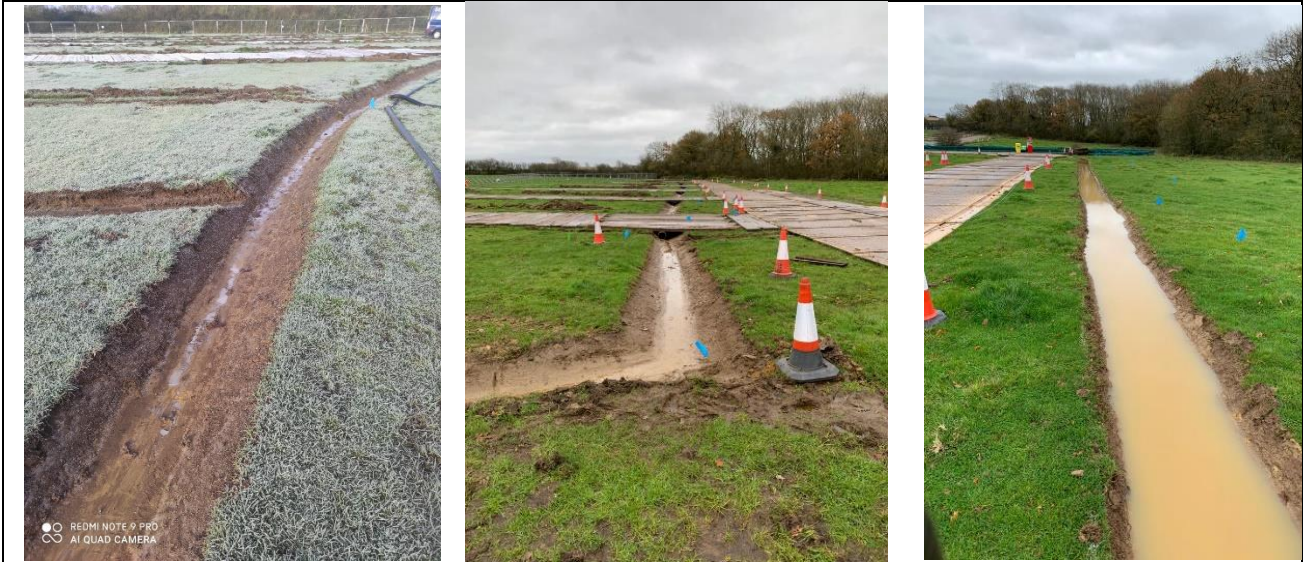
**Above:** Network of grips at edges of cells connect to central channels positioned left and right of main haulage route

<b>Solutions</b>	
<p><u>Receptor site:</u></p> <ul style="list-style-type: none"> <li>The overall area was divided into 4 No. main areas; either side of the central ditch which bisected the site and of the main haul route which was protected with trackmats and formed a central 'spine' through the site.</li> <li>RSK devised both a passive and an active surface water and silt management system as shown in <b>Figure 1</b>.</li> </ul> <p><b>Passive system:</b> Retaining 2-3m wide vegetation strips &amp; placing silt barrier fencing parallel to the existing central drainage ditch, use of reeds and rushes within the ditch to act as natural filtration mechanisms &amp; placing silt barrier fencing along the edges of the lowest working areas where water would naturally accumulate.</p> <p><b>Active system:</b> Creation of an extensive network of shallow drainage 'grips' across the receptor site which fed into collection 'sumps' and to a silt treatment system.</p> <ul style="list-style-type: none"> <li>Within each area, drainage 'grips' were formed by an excavator working from a series of bog mats which led from the main haul route. At no time did the excavator drive on unprotected soils; this would have led to soil compaction which would have exacerbated the drainage problems and soil plasticity effect.</li> <li>The grips comprised a series of shallow trenches excavated to a depth of approximately 180-200mm, depending on local conditions. This allowed free draining of the top 150mm of topsoil which was to be stripped and replaced by ancient woodland soils.</li> <li>The depth of the grip was above the subsoil layer at circa 200mm depth. Digging to expose the subsoil layer</li> </ul>

- Once the grip network was in place, each 'cell' was drained on 3 sides so the network had the capability to rapidly drain standing pools of water and saturated soils in cells quickly, following heavy rainfall events.

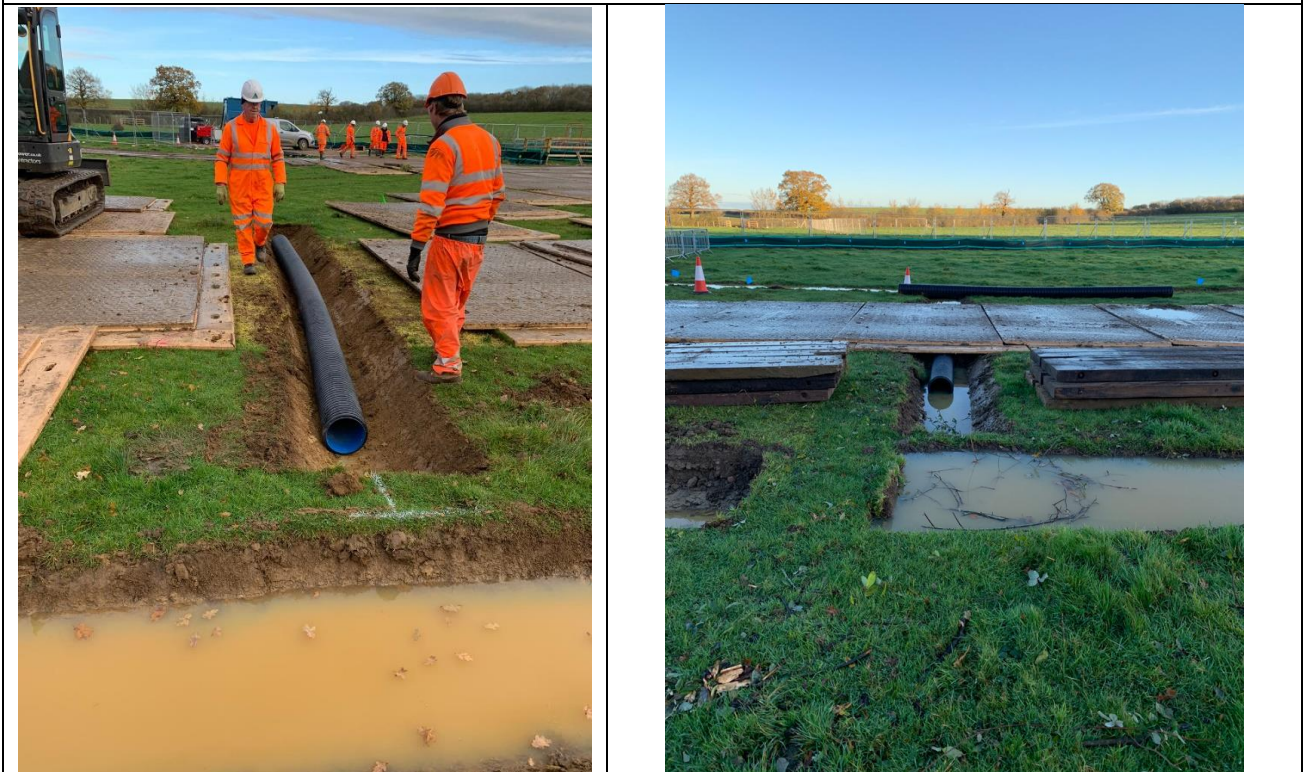
**Above:** Pipes laid underneath haul route to allow movement of water from central channels to sumps

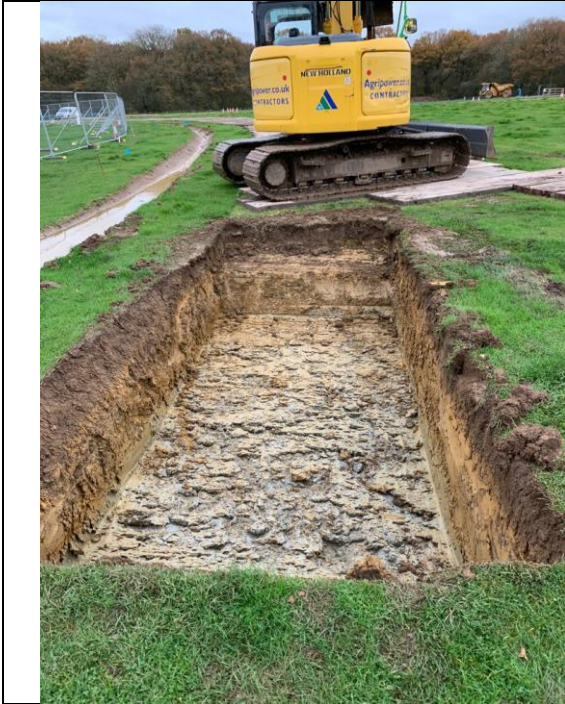
**Above:** Excavation of area on northern boundary to create drainage sump

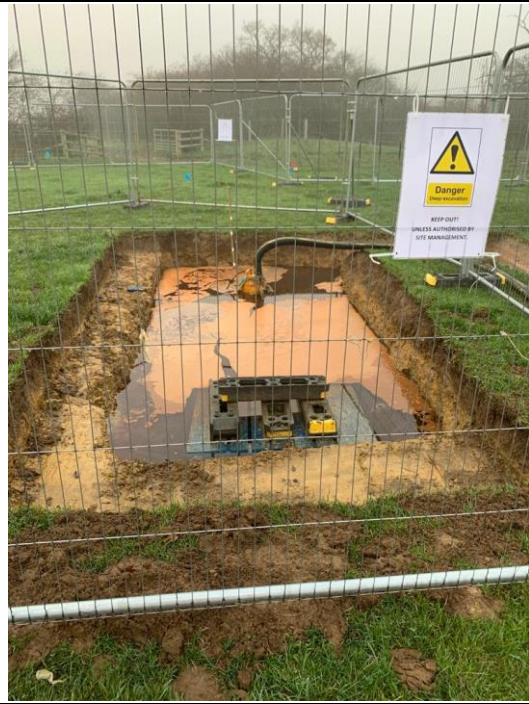
**Above:** Silt laden sump being pumped out – pipe leads to silt treatment system off photo to right

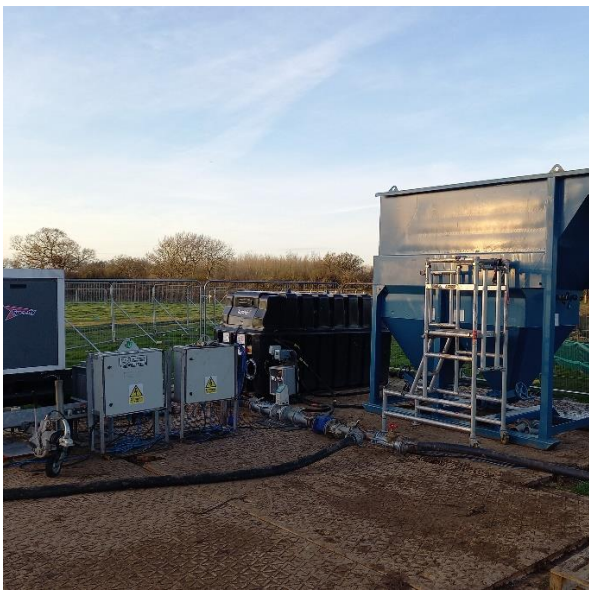
**Above:** Taytech silt management and monitoring system

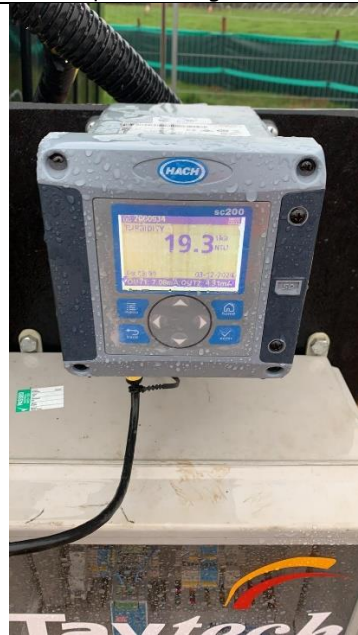
**Above:** Silt level monitoring device
